**Flood Control Project Maintenance  
Levee Inspections**

**Fall 2010 Levee Maintenance Deficiency Summary Report**

**Reclamation District No. 2101 Blewett**

**Levee Inspection Report By Mile - Fall 2010**

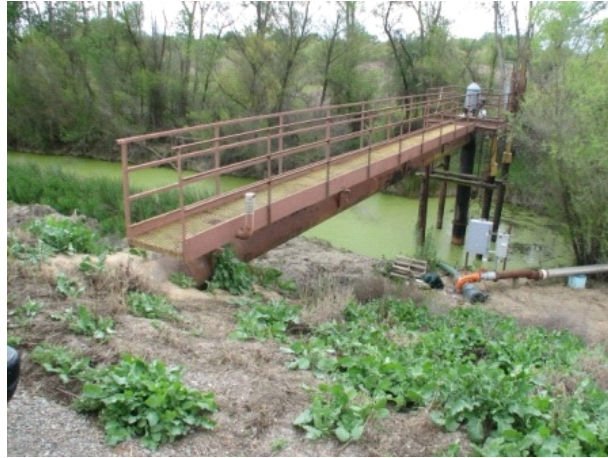
Levee Mile Report Line	5
Start Levee Mile	0.19
End Levee Mile	0.19
Location	Crown
Category	Earthen Levee
Item	Encroachments

Drainage discharge under levee crown.

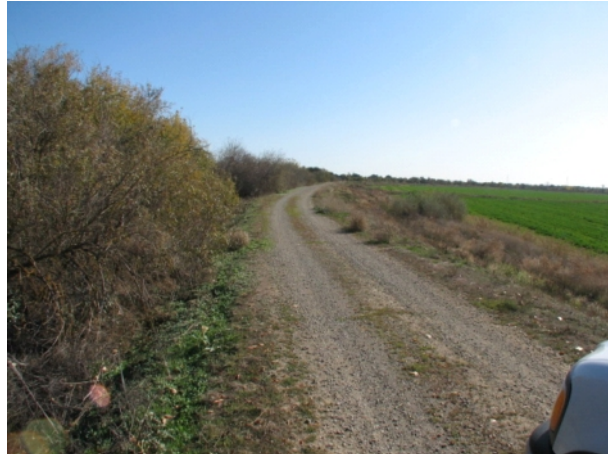
Levee Mile Report Line	8
Start Levee Mile	0.49
End Levee Mile	0.49
Location	Water Side
Category	Earthen Levee
Item	Trim / Thin Trees

Trees on top 20-ft of waterside slope block access and visibility.

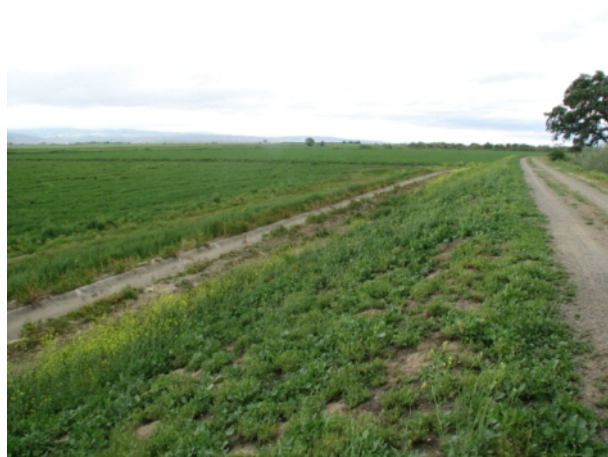
Levee Mile Report Line	11
Start Levee Mile	0.76
End Levee Mile	1.80
Location	Land Side
Category	Earthen Levee
Item	Encroachments

Concrete ditch near landside toe.

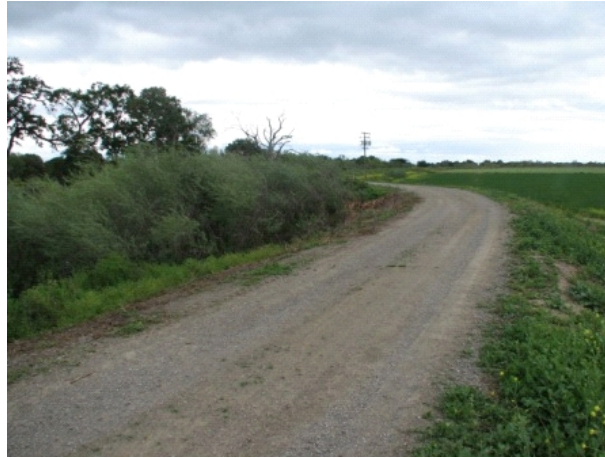
Levee Mile Report Line	18
Start Levee Mile	1.61
End Levee Mile	1.82
Location	Water Side
Category	Earthen Levee
Item	Vegetation

Obstructive vegetation on waterside slope within 20' of crown.

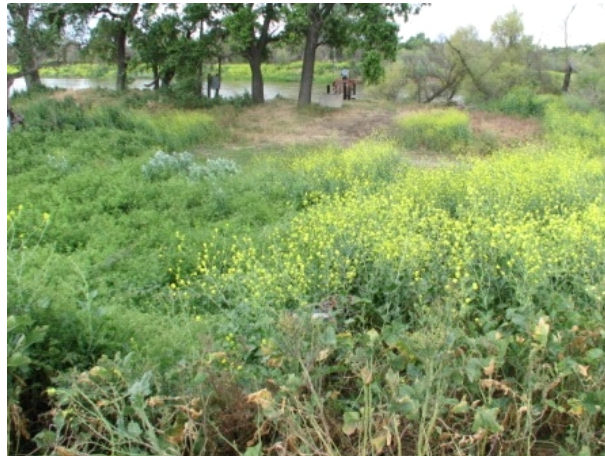
Levee Mile Report Line	19
Start Levee Mile	1.61
End Levee Mile	1.61
Location	Water Side
Category	Earthen Levee
Item	Encroachments

Photo of pump in background and CMP riser with valve in foreground.

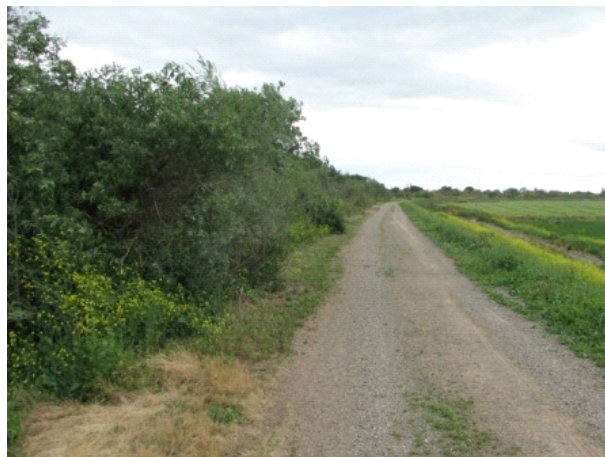
Levee Mile Report Line	20
Start Levee Mile	1.62
End Levee Mile	1.84
Location	Water Side
Category	Earthen Levee
Item	Trim / Thin Trees

Trees on top 20' of waterside slope obstruct access and visibility.

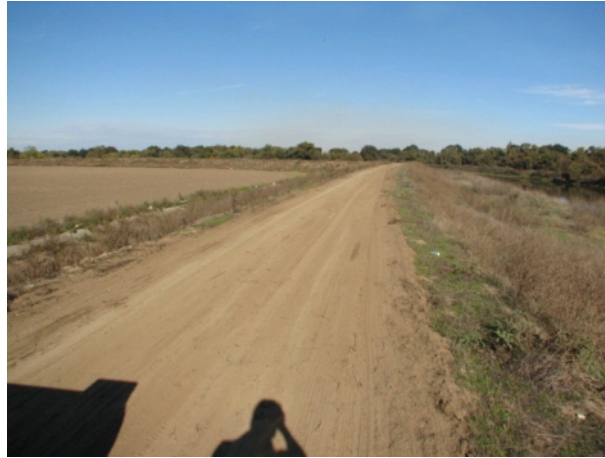
Levee Mile Report Line	23
Start Levee Mile	1.85
End Levee Mile	2.61
Location	Water Side
Category	Earthen Levee
Item	Vegetation

Vegetation on slopes obstructs visibility.

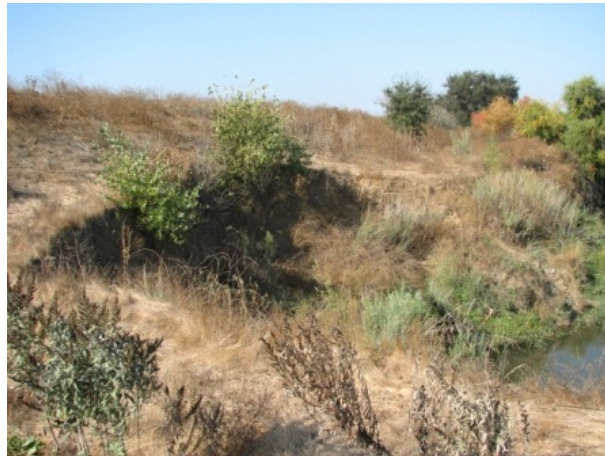
Levee Mile Report Line	24
Start Levee Mile	1.91
End Levee Mile	2.00
Location	Water Side
Category	Supplemental
Item	DWR Erosion Survey

Looking downstream at a section of the erosion site where scouring caused by an eddy has occurred.

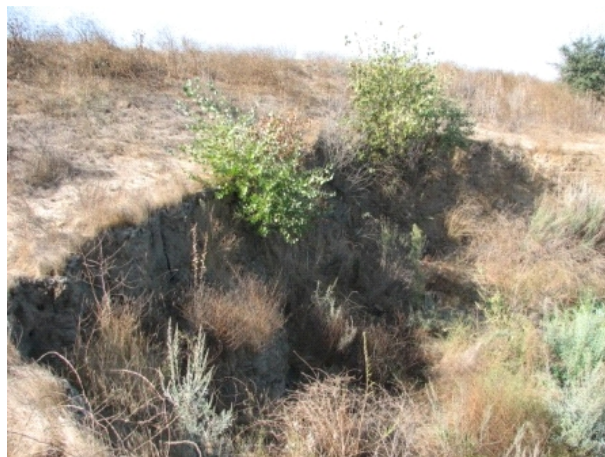
Levee Mile Report Line	24
Start Levee Mile	1.91
End Levee Mile	2.00
Location	Water Side
Category	Supplemental
Item	DWR Erosion Survey

Looking downstream at the 100-ft long scour.

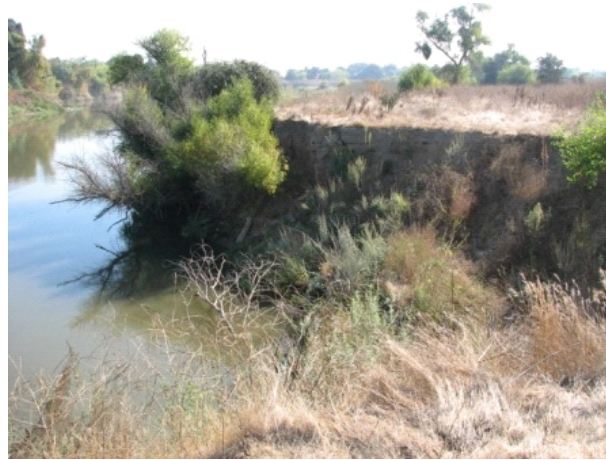
Levee Mile Report Line	24
Start Levee Mile	1.91
End Levee Mile	2.00
Location	Water Side
Category	Supplemental
Item	DWR Erosion Survey

Looking upstream at the scour site.

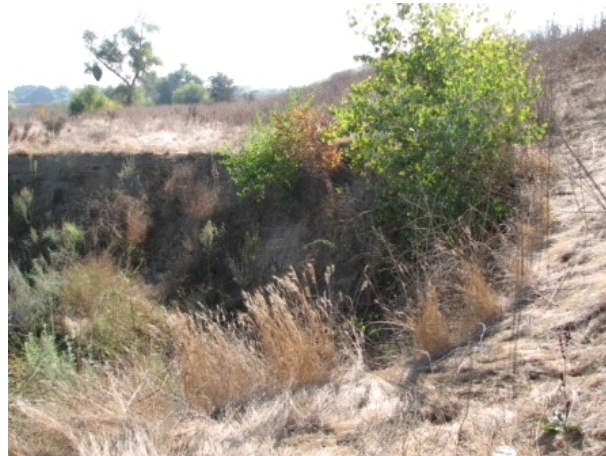
Levee Mile Report Line	24
Start Levee Mile	1.91
End Levee Mile	2.00
Location	Water Side
Category	Supplemental
Item	DWR Erosion Survey

Looking upstream at the scour site.

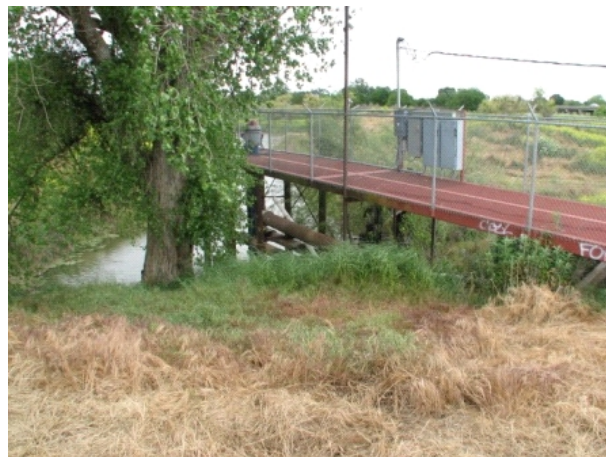
Levee Mile Report Line	30
Start Levee Mile	2.74
End Levee Mile	2.74
Location	Water Side
Category	Earthen Levee
Item	Encroachments

Irrigation intake near Maze Blvd.

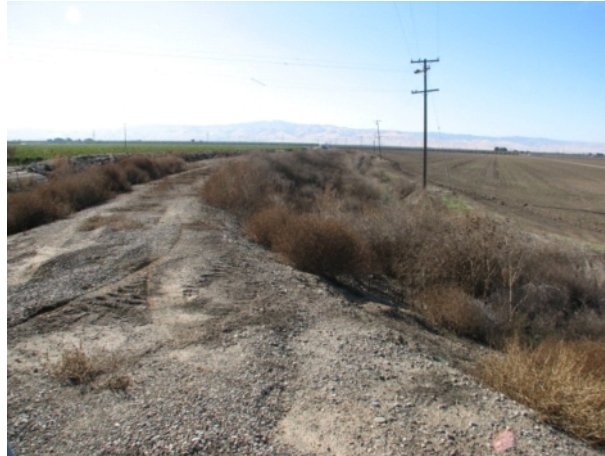
Levee Mile Report Line	31
Start Levee Mile	2.85
End Levee Mile	3.20
Location	Land Side
Category	Earthen Levee
Item	Vegetation
Weeds on levee slope obstruct access and visibility.	
jpaasch_f_20101110_541.jpg

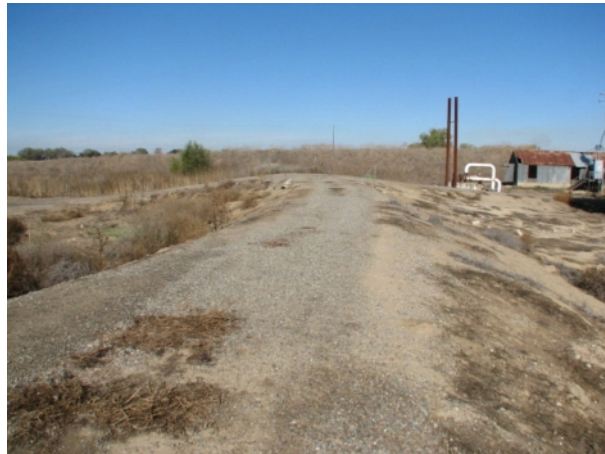
Levee Mile Report Line	31
Start Levee Mile	2.85
End Levee Mile	3.20
Location	Land Side
Category	Earthen Levee
Item	Vegetation
Vegetation on landside slope near Maze Blvd obstructs visibility.	
jpaasch_f_20101110_544.jpg

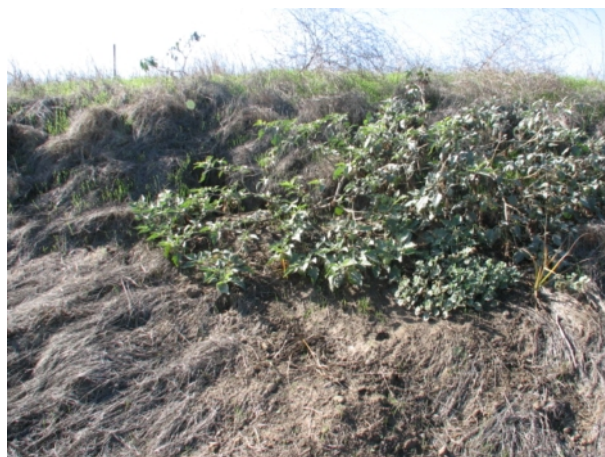
Levee Mile Report Line	32
Start Levee Mile	2.88
End Levee Mile	2.88
Location	Water Side
Category	Earthen Levee
Item	Animal Control
Rodent holes on levee slope hidden by vegetation.	
jpaasch_f_20101110_539.jpg

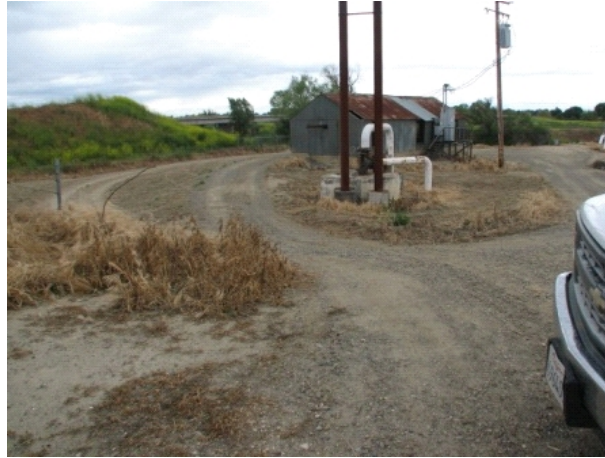
Levee Mile Report Line	33
Start Levee Mile	2.89
End Levee Mile	2.89
Location	Water Side
Category	Earthen Levee
Item	Encroachments

Risers on waterside berm and risers along road leading to levee indicate presence of pipe penetration.

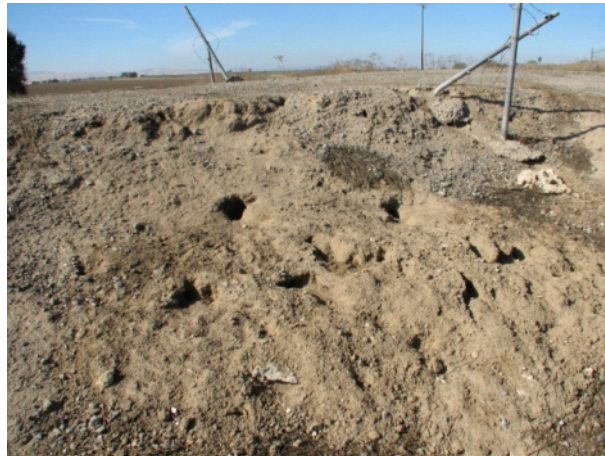
Levee Mile Report Line	34
Start Levee Mile	2.89
End Levee Mile	2.89
Location	Land Side
Category	Earthen Levee
Item	Animal Control

Rodent holes on levee slope.

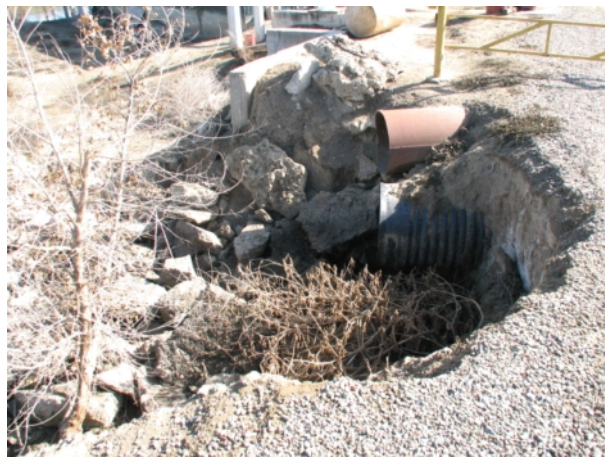
Levee Mile Report Line	35
Start Levee Mile	2.91
End Levee Mile	2.91
Location	Water Side
Category	Earthen Levee
Item	Erosion / Bank Caving

Levee slope is being eroded at this location. Repair needed to preserve access road.

35	2.91	2.91	Earthen Levee	Erosion / Bank Caving	WS	M	Schedule repair of erosion site prior to the next inspection.	37.639852 ° -121.229980 °	37.639852 ° -121.229980 °	29 Y
36	2.91	2.91	Earthen Levee	Encroachments	WS	W	Pipe	37.639824 ° -121.230005 °	37.639824 ° -121.230005 °	24 Y
37	2.95	3.20	Earthen Levee	Encroachments	CR	U	Agricultural tilling Inspector Comments: Though discing has removed weeds, this has damaged the patrol road on the levee crown has severely limited access.	37.639399 ° -121.230384 °	37.637066 ° -121.233780 °	30 Y

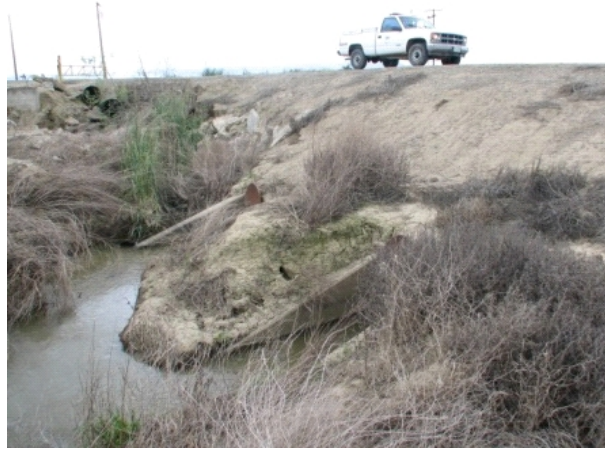
Levee Mile Report Line	36
Start Levee Mile	2.91
End Levee Mile	2.91
Location	Water Side
Category	Earthen Levee
Item	Encroachments

Drainage discharge to San Joaquin River.

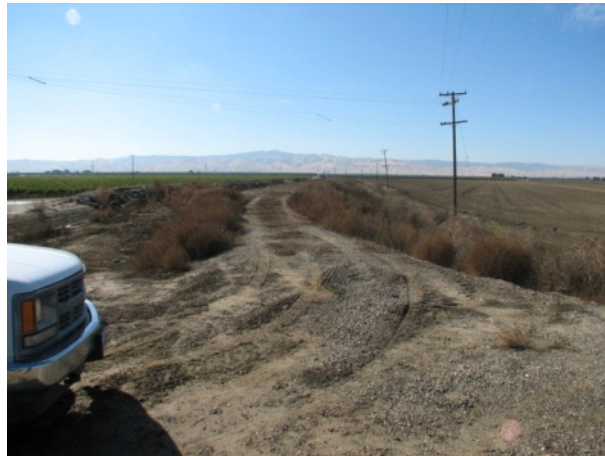
Levee Mile Report Line	37
Start Levee Mile	2.95
End Levee Mile	3.20
Location	Crown
Category	Earthen Levee
Item	Encroachments

Discing of crown roadway surface limits accessibility.

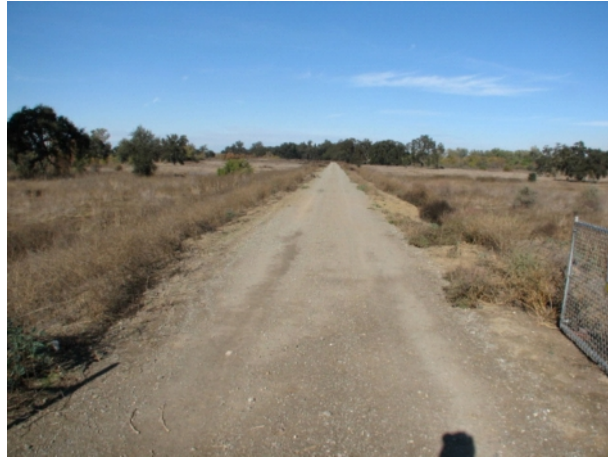
Levee Mile Report Line	1
Start Levee Mile	0.00
End Levee Mile	0.30
Location	Water Side
Category	Earthen Levee
Item	Vegetation

Tall weeds on levee slope obstruct visibility.

LMR No.	Levee Mile		Category	Item	* Location	** Rating	Action/Comment	GPS Latitude/Longitude		Issue No. Photo
	Start	End						Start	End	
1	0.00	0.30	Earthen Levee	Vegetation	WS	M	Remove the wild growth other than native grasses from the levee slopes.	37.659774 ° -121.243522 °	37.663866 ° -121.242869 °	1 Y
2	0.31	0.31	Earthen Levee	Erosion / Bank Caving	WS	M	Schedule repair of erosion site prior to the next inspection. Inspector Comments: At the end of this spur two rivers converge and due to past high water events a large scour hole has been formed. It is now filled in with vegetation. The next HW event could further scour this large hole.	37.663998 ° -121.242925 °	37.663998 ° -121.242925 °	2
